## Troubleshooting High SWR on 3-element SteppIR Yagi Antenna 3/26/2016 by Don Hill, AA5AU

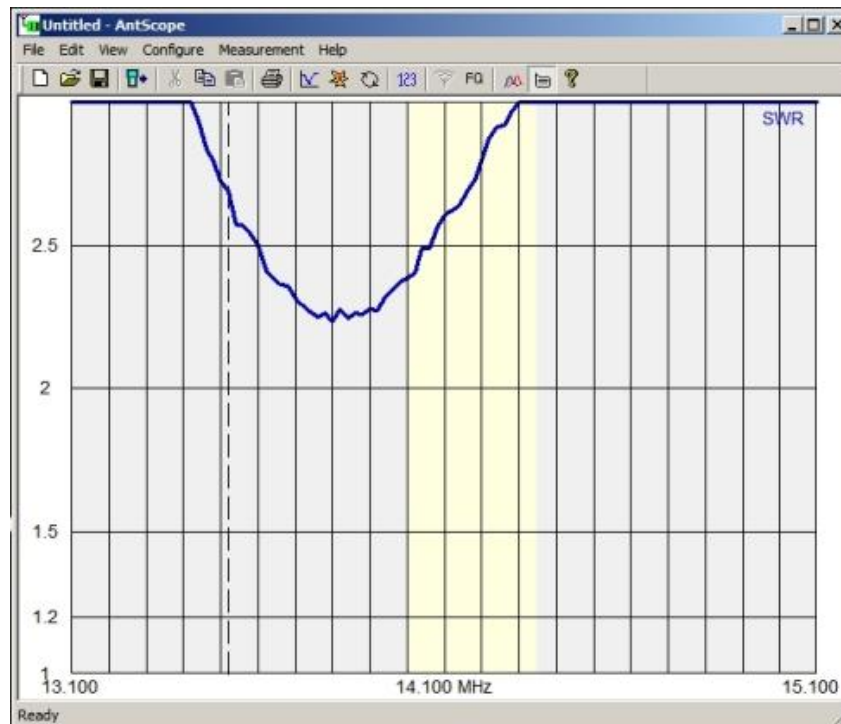
Figure 1

I set the antenna on 20 meters (14.100 MHz) and moved the Reflector in and out using Create/Modify and the SWR graph (Figure 1 below) did not change. I then moved the Director in and out using Create/Modify and the SWR graph did not change. Moving the Driven element in and out drastically changed the SWR graph. I suspected that neither the director or reflector elements were working.

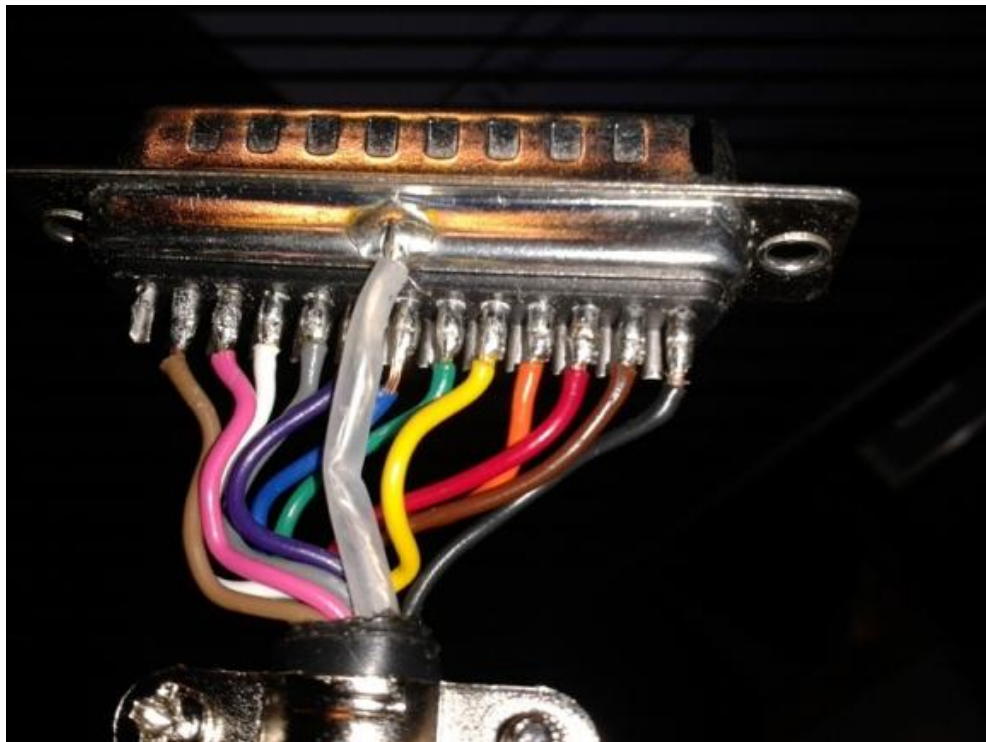
Photo A

There was the problem. One pair going to the Director was open and one pair going to Reflector was open. I took the shell off the DB25 connector that goes into the back of the controller and inspected the solder connections. They looked good.

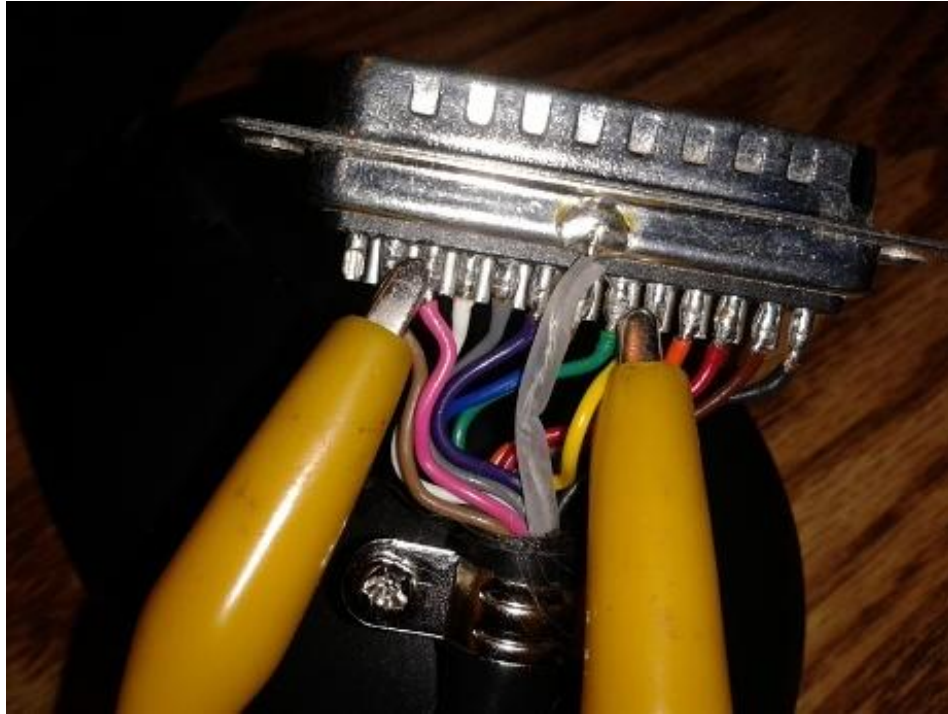
Photo B

The next step was to check the cable from the connector to the connector box located on the boom of the antenna. Something else I learned from last November was to place a short across all suspect cable pairs so I could check to see if the cable going up the tower was open or good. With the cable disconnected from controller, I shorted wires 5, 6, 11 and 12 together with a clip lead (Photo B below).

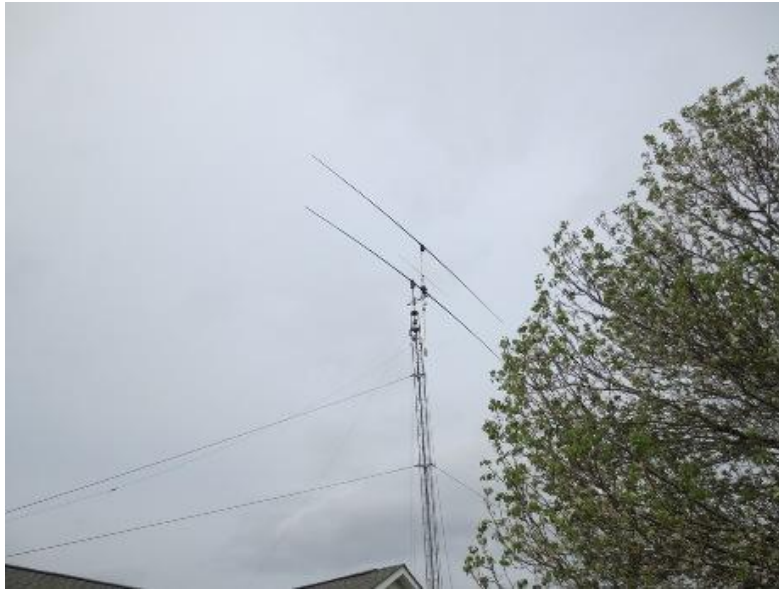
Photo C

While on the ground I took a picture of the antenna with the Reflector removed (Photo C – above) and a picture of the Reflector on the ground (Photo D – below). The tower in the background (below), next to the tree, houses my 2-element SteppIR yagi. I had checked it earlier and thankfully it was working fine. I can only deal with one SteppIR problem at a time!

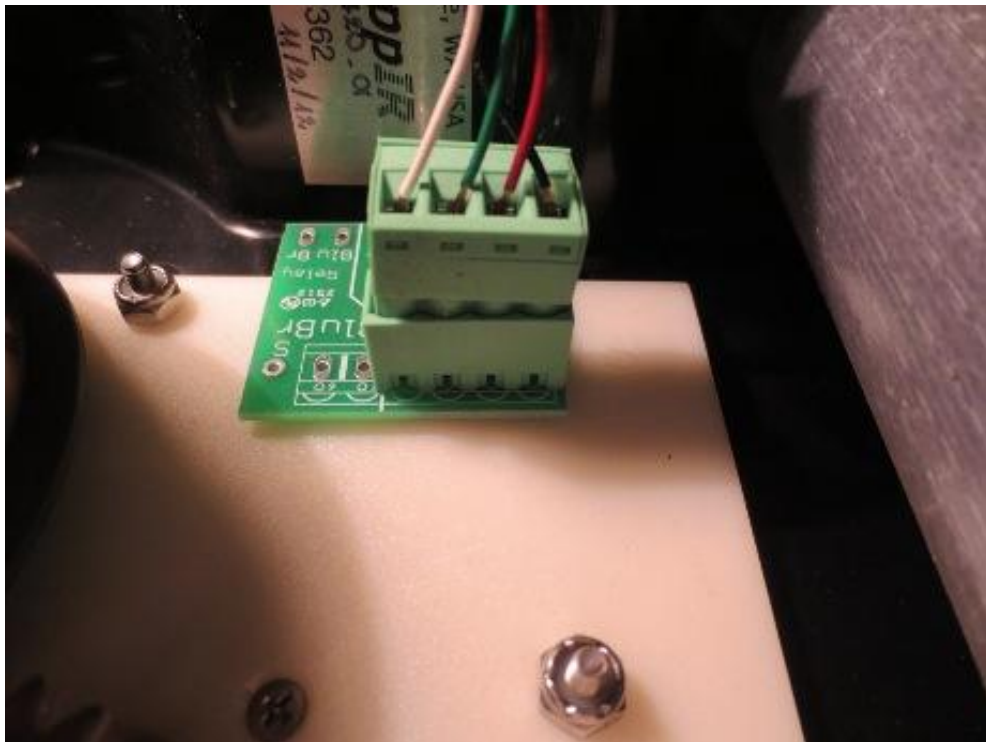
I opened the Director EHU first. I saw the inside connector had worked itself partially out of its socket (see Photo E below). I gently pushed on it and it seated back into the socket. I measured the winding resistance at the connector and it now checked OK on both windings. I couldn't believe it. I then opened the other EHU and it had the same exact problem except it was cocked in the opposite direction. These connectors sit upside down in the EHU when installed on the antenna. Apparently, shaking from the rough weather we had this week, along with the force of gravity, caused the connectors to unseat from the jack. They did not fall completely out but they were not seated in all the way. I know it wasn't installed this way. The antenna has been up for over three years and I just reworked the reflector EHU in November. These connectors are not used on earlier model yagi antennas. This antenna was purchased and installed in 2012. My 2-element SteppIR which was originally purchased as a 3-element in 2010 does not use these connectors. The cable is hardwired to the motor on that earlier model antenna.
